Independent Monitor Community Report

2010 Operational Period

Community Report by the Independent Monitor of the
McArthur River Mine, November 2011

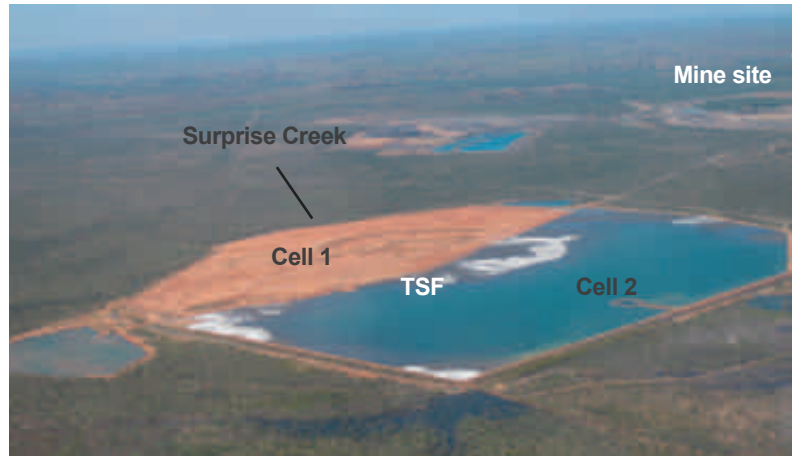
Aerial view of the Tailings Storage Facility (TSF) Cells 1 and 2. Cell 1 has now been covered with a clay to suppress tailings dust. Cell 2 is receiving tailings waste from the Mine, but was also storing more water than it should in May 2011

Tailings dust blown from surface of TSF Cell 1 has been an issue during previous audits, and has been contaminating stream sediments in Surprise Creek. However, further dust generation has now been mitigated by the completion of a clay cap which covers the dried tailings in TSF Cell 1 (see photo top of Page 1).

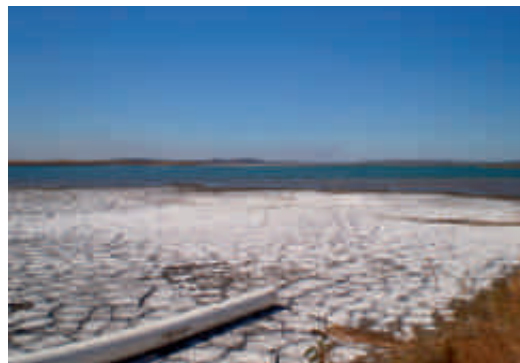
The volume of water held within TSF Cell 2 is again of concern this audit period. At the water levels we observed in May this year, the TSF would not be able to contain additional rainfall water if a 1 in 200 year rainfall event were to occur, which could lead to the instability of the TSF walls or contaminated water overtopping spillways.

Tailings 'beach' recently deposited at the edge of TSF Cell 2, with excess water in the background - Photo taken in May, 2011.

MRM have since reduced the water level in the TSF through evaporation on tailings beaches (see photo left), through evaporative fans, and water recycling at the Mine site. We will continue to monitor this issue closely over the next monitoring period.

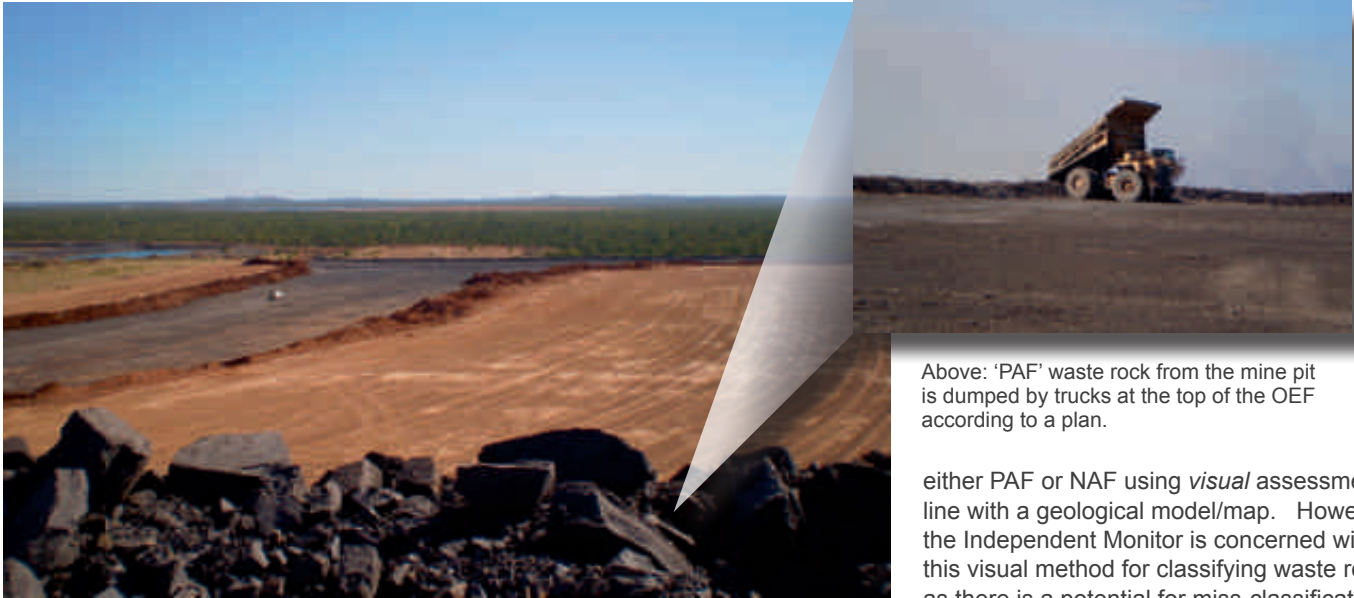
View from the top of the OEF looking at the clay base, with waste rock piled in the foreground.

Waste rock from the mine pit is placed in the '**Overburden Emplacement Facility**' (OEF). This facility will be a permanent structure that can produce acid leachate or become unstable in future if not managed appropriately.

either PAF or NAF using *visual* assessment in line with a geological model/map. However, the Independent Monitor is concerned with this visual method for classifying waste rocks, as there is a potential for miss-classification and miss-placement of PAF rocks within the

OEF. MRM are currently undertaking a further drilling program to improve and revise their waste classification methods, and will investigate in-place testing of waste material in 2012.

The OEF design must minimise acid generation by stopping rainwater infiltrating through the PAF rock. It does this by placing a clay layer over the top of the PAF material and at the base of the OEF (see photo top left). Only part of the clay cover was completed at the time of our inspection, and we have recommend that it be completed and armoured prior to the heavy rainfalls of the wet season. A careful watch of the clay placement also needs to be maintained so that the correct thickness is achieved.

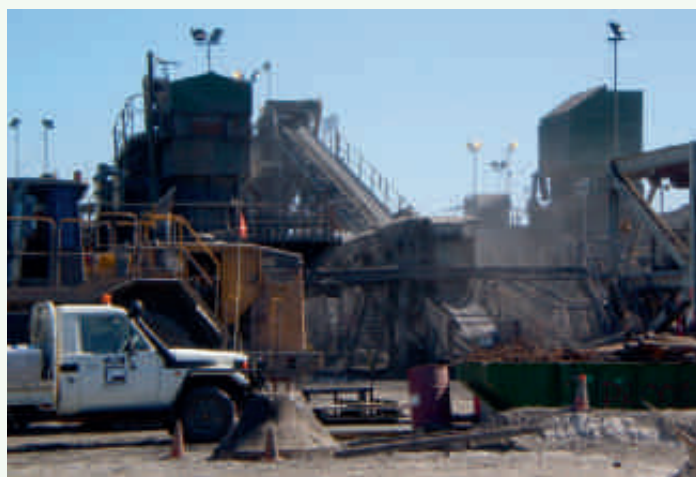
The 'PACRIM' ore crushing plant is the primary source of contaminated dust generated at the Mine site. Dust needs to be further reduced here.

The ore crushing machinery at the Mine site known as the 'PACRIM' (see photo left) is the primary source of contaminated dust at the Mine. Water sprays are being used throughout the crushing system, however, lead and zinc dust is still escaping from this area and settling over the nearby landscape. The laboratory results from nearby dust monitoring gauges on the Barney Creek floodplain indicate that the amount of contaminated dust has not improved.

Further efforts to control fugitive dust emissions are needed at the Mine site, particularly in the PACRIM area to avoid further unnecessary contamination. However we do note that zero dust emissions may not be possible at this facility.

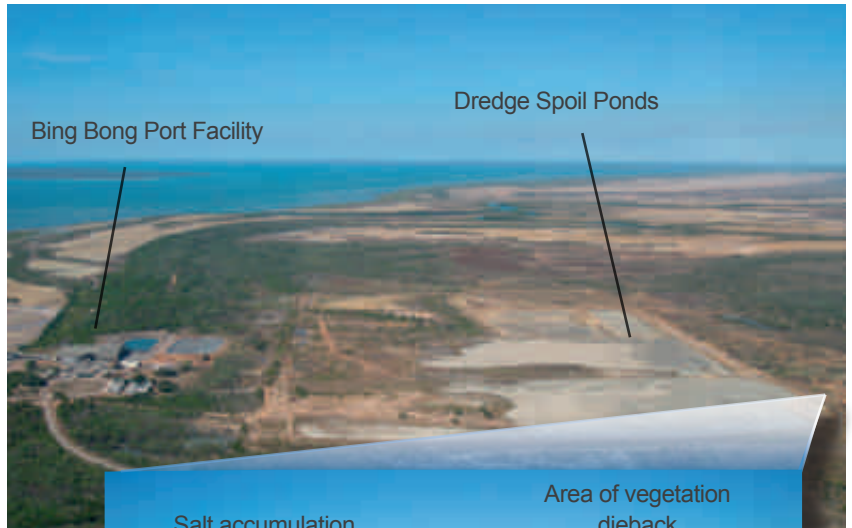
Vegetation affected by dredge spoil seepage

Vegetation dieback surrounding the dredge spoil has been caused by saline seepage from the spoil ponds. This has been an issue raised by the Independent Monitor in previous audits. In 2009, it was flagged as an urgent issue requiring immediate attention. In response, MRM constructed a spoon drain outside the dredge spoil walls to redirect saline seepage back out to sea and reduce the effects on the surrounding vegetation. The Independent Monitor has inspected the spoon drain in 2010 and 2011, and it appears to be effective (see photos right).

MRM continue to monitor salt levels in soil, and have been monitoring the areas of vegetation dieback through aerial survey photos of the dredge pond area. However, MRM has not provided any interpretation or discussion of the photos. We recommend that MRM compare yearly photographs to identify any quantitative changes in vegetation cover in salt-affected areas. Judging from our photographs and site inspections, there has been no significant visible increases in the vegetation coverage at this stage, but this is likely to be a slow process. We will continue to monitor this issue.

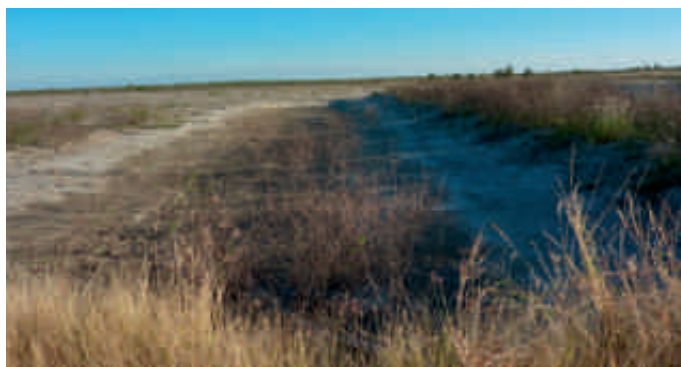
A PhD student from Charles Darwin University (CDU) was scheduled to undertake a plot trial study on the dredge spoil to investigate how future revegetation might be achieved. In preparation for this study, MRM constructed a number of plot trial areas at the dredge spoil (see photo below). However, the revegetation study did not commence due to the student pulling out. MRM are discussing alternatives such as contracting the work to a consultant.

Left: Dredge spoil revegetation plot trial area constructed on the dredge spoil by MRM in preparation for a PhD student study, which has not yet eventuated.

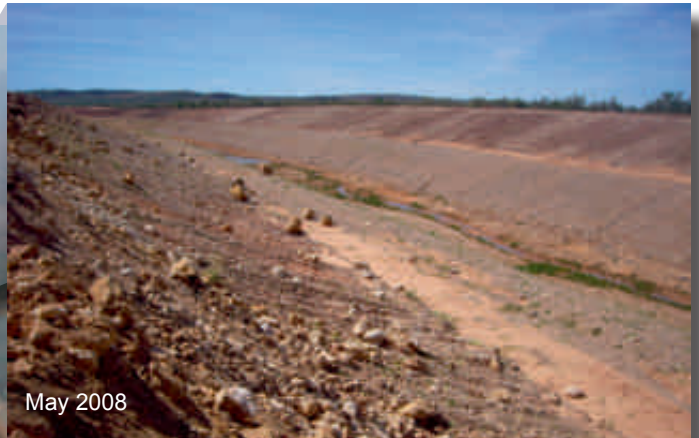
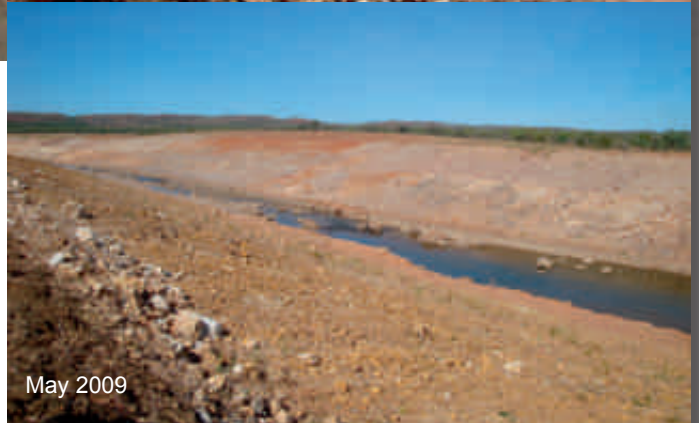
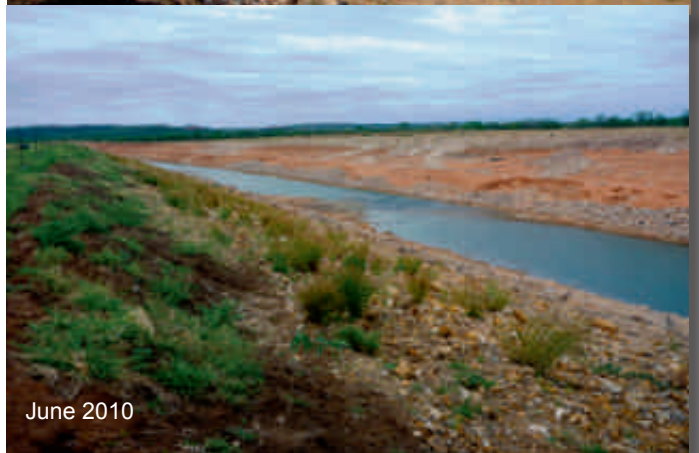
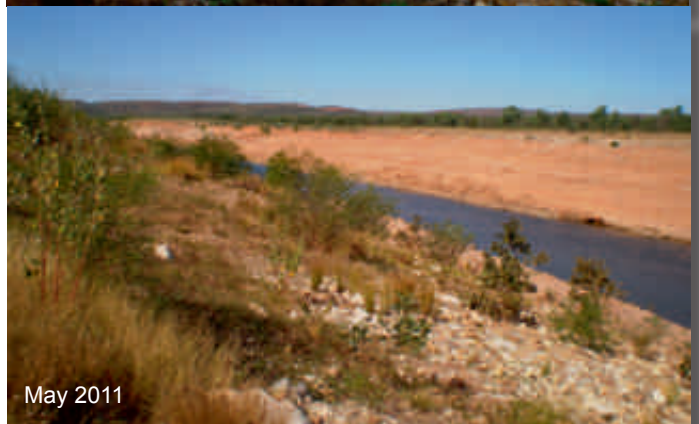
Above: Series of photographs taken in 2009, 2010 and 2011, showing the outer toe of the spoil ponds, with the spoon drain subsequently installed in late 2009 to redirect saline seepage out to sea.

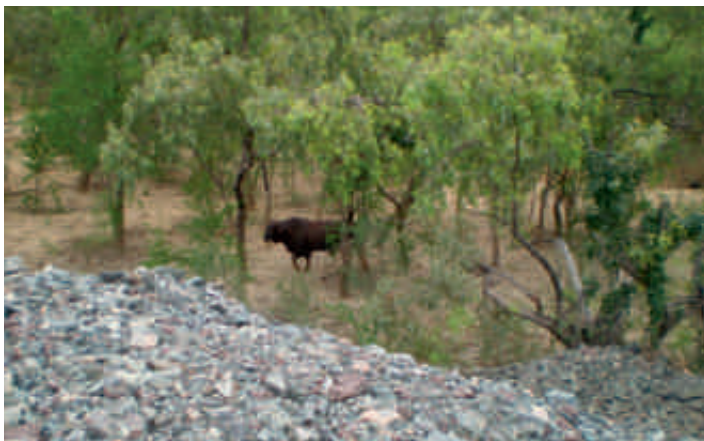
Revegetation has only been undertaken on the mine-side bank of the diversion at this stage, and the opposite bank still remains un-vegetated. Furthermore, most of the revegetation efforts have been undertaken on the upstream section of the McArthur River Diversion. Due to access restraints caused by the recent wet season, the downstream section of the Diversion could not be inspected by the Independent Monitor this year.

Above: Progressive establishment of vegetation on the mine side of the McArthur River Diversion from 2008-2011. Revegetation is improving, however further works downstream and on the opposite bank are required in coming years.

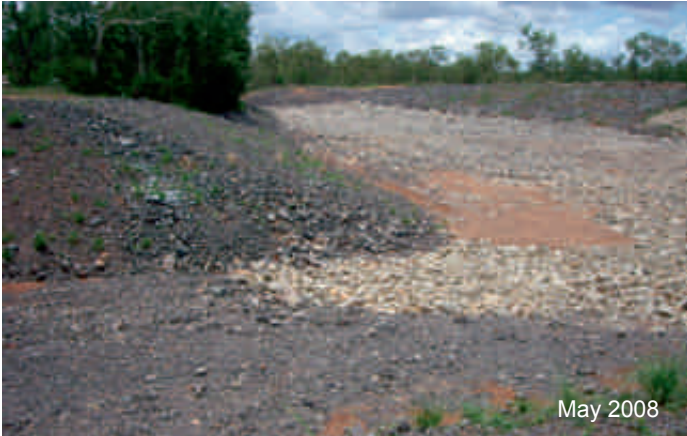
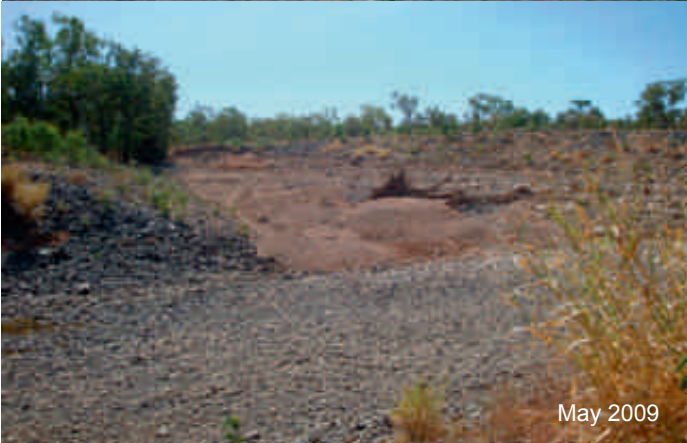
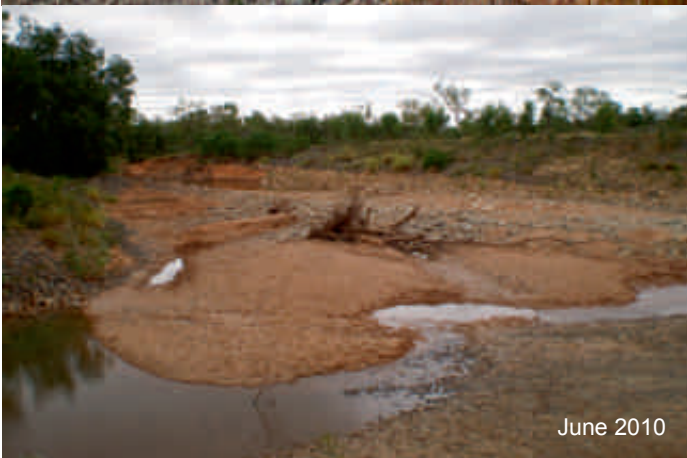
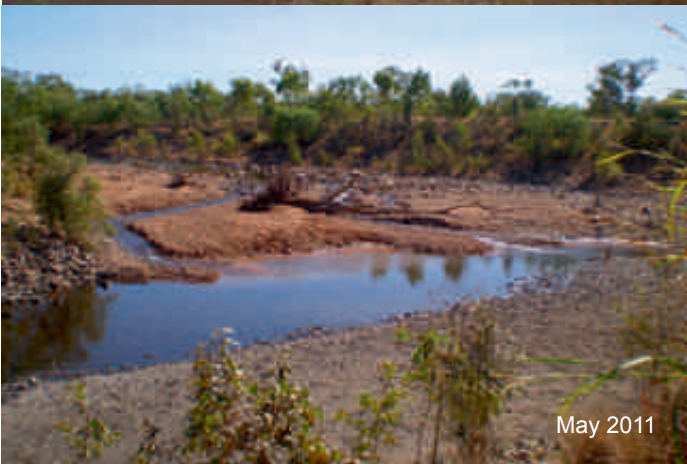
Re-vegetation of the Barney Creek Diversion is progressing well, as we have observed over the past four years of monitoring.

Barney Creek Diversion vegetation growth has continued to improve since the Independent Monitor's last inspection. We note that flood velocities are not as high along this part of Barney Creek, which have allowed for successful revegetation in this area. Also, this area was planted one year prior to revegetation at the McArthur River Diversion, so it exhibits additional growth.

Further revegetation efforts downstream in the Barney Creek Diversion are still required in coming years.

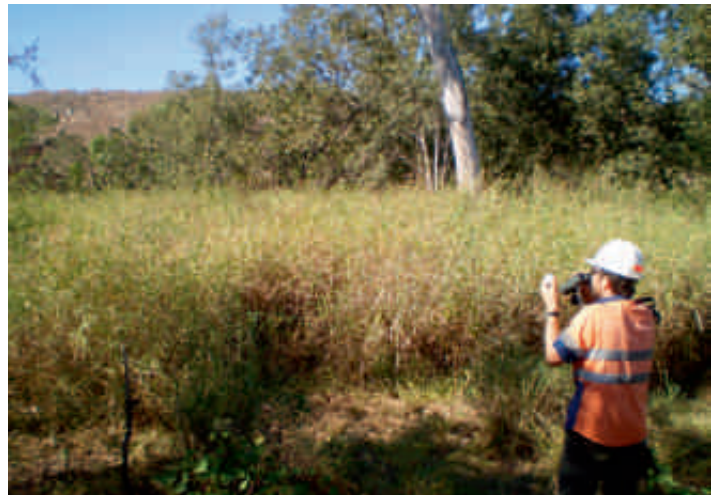
Cane grass was observed to be providing habitat for the Purple Crowned Fairy Wren during our site inspection in May 2011. This suggests that revegetation of cane grass is proving successful in these early stages (see photo below).

MRM Staff monitoring a Purple Crowned Fairy Wren population in revegetated cane grass habitat along the Barney Creek Diversion in May 2011.

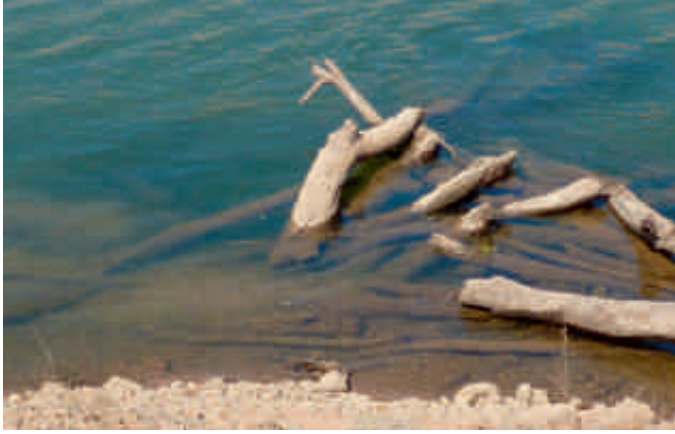
Woody debris placed in the river diversions provides essential shelter for fish.

Fish recaptures in the tagging program have begun to provide information on fish movements. The placement of woody debris also appears to be improving habitat for fish in the McArthur River Diversion. We observed approximately 10 fish species around one of these log jams during the May 2011 site inspection (see photo top left).

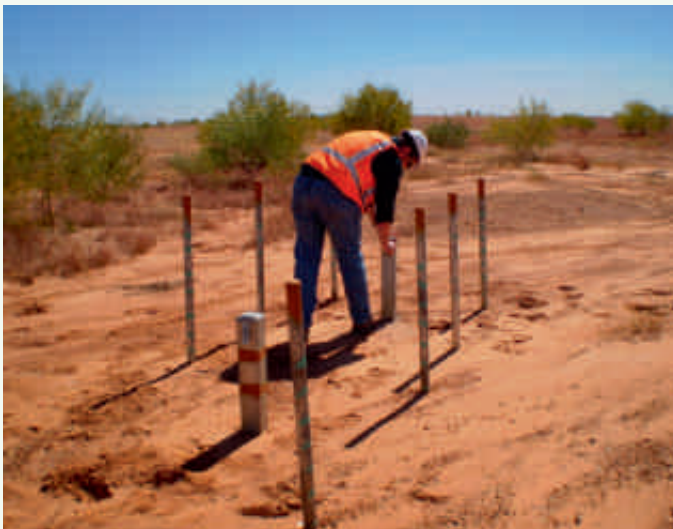
Groundwater monitoring and reporting has improved since the previous audit periods and additional groundwater bores have been added at the TSF (see photo left) and at Bing Bong. However, groundwater monitoring results prepared by both MRM and external consultants were found to be poorly discussed and inadequate to detect impacts to natural groundwater systems. We have made recurring recommendations for MRM to provide appropriate discussions of results as well as undertake quality control and quality assurance reporting. These requests have not yet been met.

Independent Monitor Hydrogeologist, Geordie McMillan inspecting two new groundwater bores installed within the TSF Cell 1.

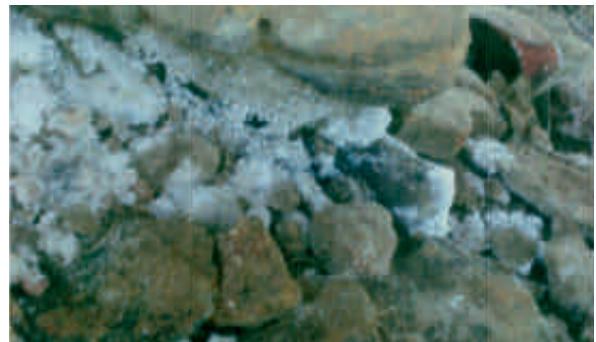
More white material was reported at the Surprise Creek Bridge in December 2010 by the Environment Centre NT (see photo right). The area of impact was inspected by the DoR on 13 December 2010, yet the DoR officers inspecting the area observed only minor amounts of white material (likely to be salt) on rocks along the bank of the Creek. The DoR advised MRM that this area should be added to the MRM monitoring program.

Photograph of white material in Surprise Creek taken by a member of the Environment Centre NT. The photograph was sent to the Department of Resources, and was investigated by MRM and the DoR in December 2010.

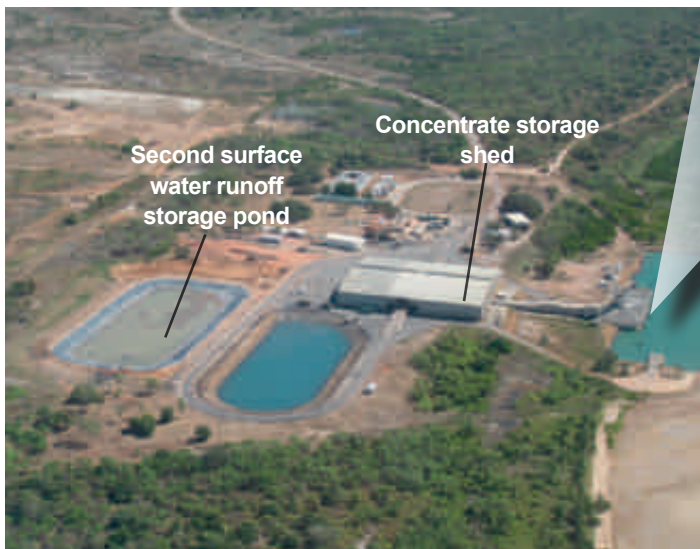
The main source of contaminated dust at Bing Bong Port comes from the concentrate storage shed. This year we observed that the doors to the shed still remain open, which is necessary to avoid gas-build-up in the shed. We have previously recommended that the doors to the shed remain shut to stop lead/zinc dust being carried by wind and contaminating the surrounding soil and marine sediments.

Aerial photograph of the Bing Bong Port Facility. Ore concentrate is stored in the large shed on site until it is loaded onto the Aburri Barge (photo right). As show above, a second surface runoff pond was constructed at Bing Bong in 2010 to store the large volume of runoff water from the site during the wet season. This runoff water is potentially contaminated with concentrate dust which escapes from the storage shed.

MRM have indicated that updates to the shed have now been approved, including an venting system, which will allow the shed doors to remain shut - these updates will begin in 2011.

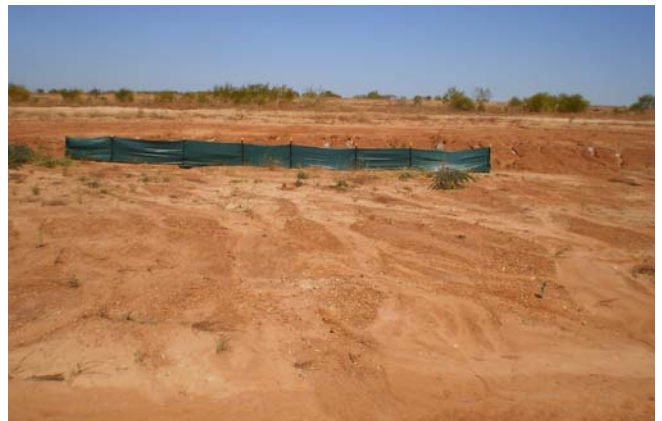
TSF Cell 1 Cap with mesh fence to stop erosion. The cap needs to be shaped next audit.

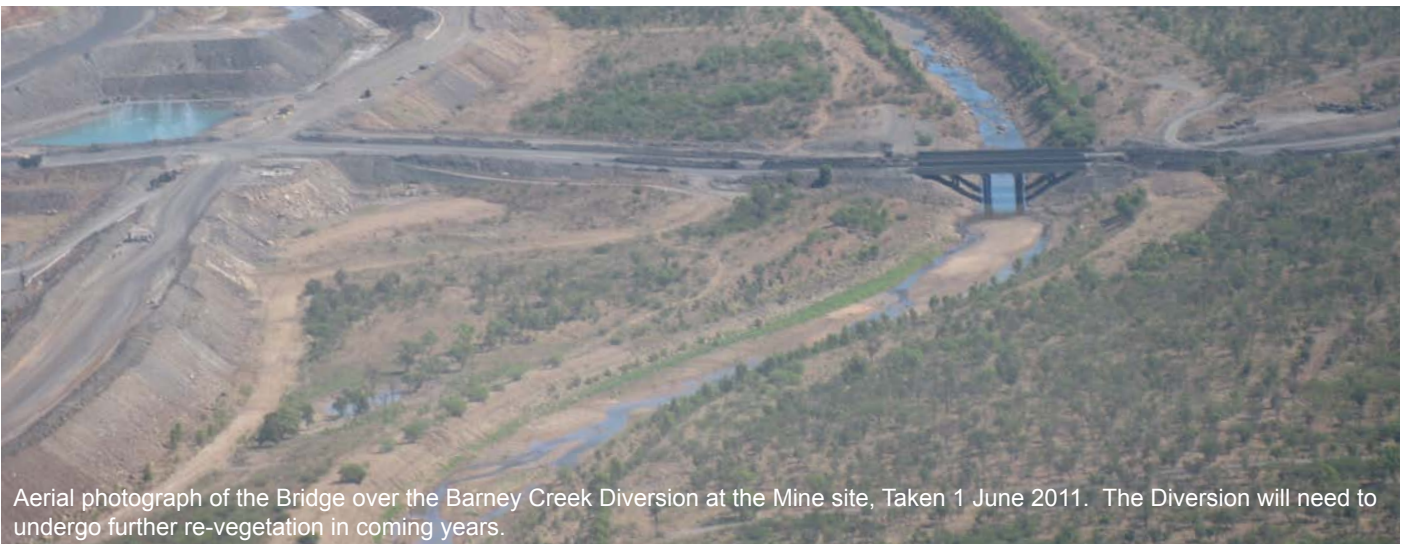
Aerial photograph of the Bridge over the Barney Creek Diversion at the Mine site, Taken 1 June 2011. The Diversion will need to undergo further re-vegetation in coming years.
