Independent Monitor Community Report

2010 Operational Period

Community Report by the Independent Monitor of the
McArthur River Mine, November 2011

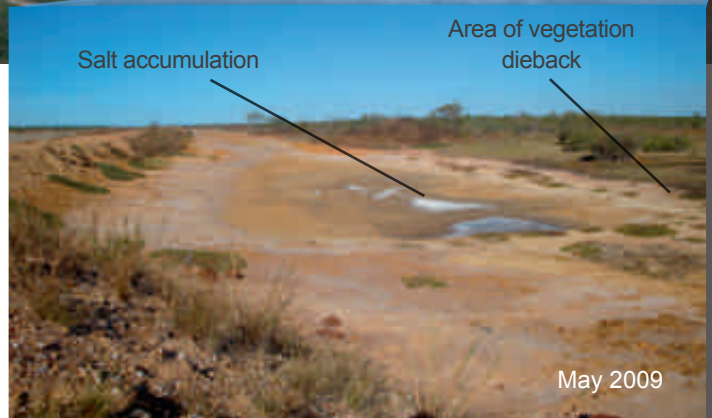
Vegetation dieback surrounding the dredge spoil has been caused by saline seepage from the spoil ponds. This has been an issue raised by the Independent Monitor in previous audits. In 2009, it was flagged as an urgent issue requiring immediate attention. In response, MRM constructed a spoon drain outside the dredge spoil walls to redirect saline seepage back out to sea and reduce the effects on the surrounding vegetation. The Independent Monitor has inspected the spoon drain in 2010 and 2011, and it appears to be effective (see photos right).

Above: Series of photographs taken in 2009, 2010 and 2011, showing the outer toe of the spoil ponds, with the spoon drain subsequently installed in late 2009 to redirect saline seepage out to sea.

MRM continue to monitor salt levels in soil, and have been monitoring the areas of vegetation dieback through aerial survey photos of the dredge pond area. However, MRM has not provided any interpretation or discussion of the photos. We recommend that MRM compare yearly photographs to identify any quantitative changes in vegetation cover in salt-affected areas. Judging from our photographs and site inspections, there has been no significant visible increases in the vegetation coverage at this stage, but this is likely to be a slow process. We will continue to monitor this issue.

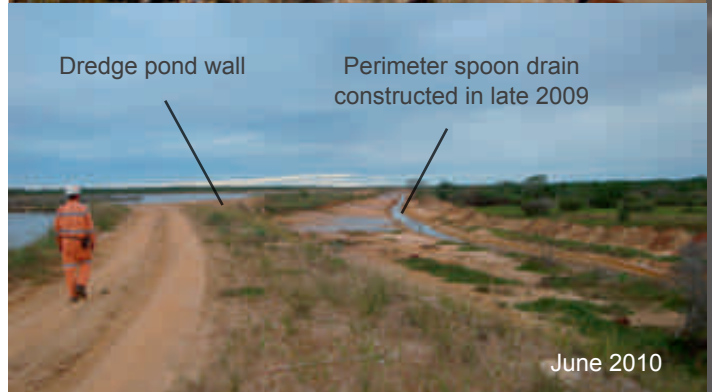
At the time of our site inspection in May 2011, the Bing Bong dredge spoil was dry, appeared to be stable and not likely to fail. However, there is still no information available regarding the geotechnical stability of the pond walls. We have recommend that MRM consider conducting a complete geotechnical review of the walls prior to the 2011/2012 wet season to determine their level of stability.

MRM have advised that further earthworks have recently been undertaken to clean out the spoon drain and repair the dredge pond walls prior to the 2011/2012 wet season.

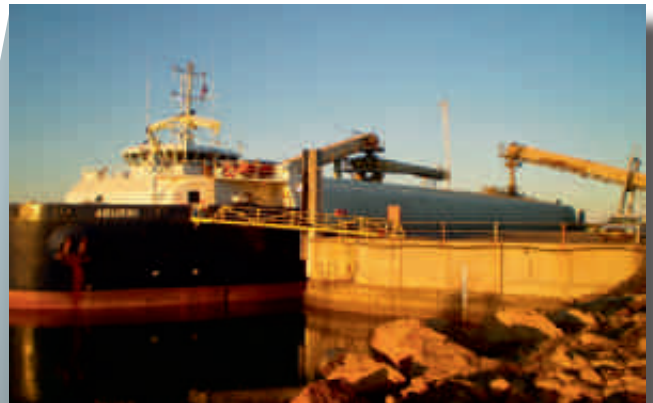
In 2010, anonymous claims were made in the *Northern Territory News* (4 May 2010) that concentrate dust had been spilt and washed off the Aburri Barge during loading and cleaning. The Independent Monitor inspected the concentrate loading process this year (see photo above) and found it to be entirely closed, with no observable dust on the pavement or coming from the loading plant.
